# Manhole Inspection Summary

Manhole # S35Q\_\_032MH

Insp Date: **3/21/08 10:20 AM**

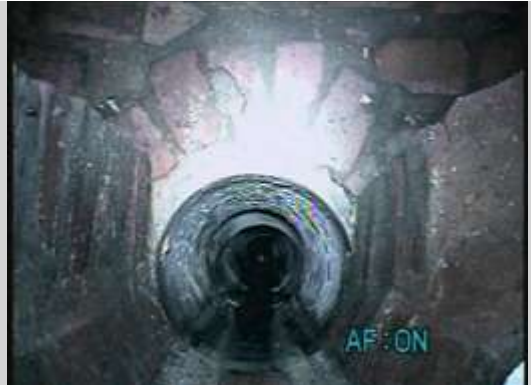
12 O'Clock Outflow

8 in. Circular Gravity Sewer  
Pipe Out @ 12 O'Clock

Invert Depth: **8.75** (ft.) Flow Characteristics: **Slow**

Infiltration: **None** Pipe Seal Cond: **Unknown**

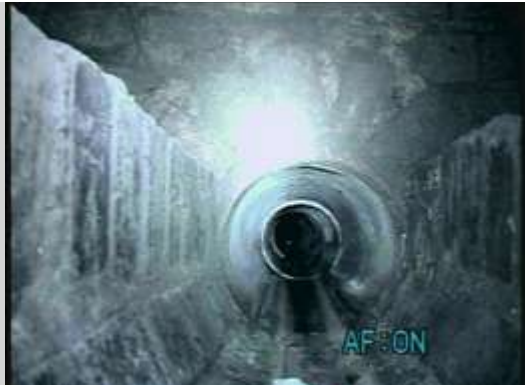
6 O'Clock Inflow

8 in. Circular Gravity Sewer

Pipe In @ 6 O'Clock

Infiltration: **None** Pipe Seal Cond: **Unknown**
